**Flood Control Project Maintenance
Levee Inspections**

Maintenance Issue Types Only, Levee Inspection Report By Mile - Spring 2018

Reclamation District No. 0785 Driver

Waterway	Bank	Unit Miles	Inspection Start/End	Inspector
Unit No. 01 Sacramento River	Right	2.26	05/01/2018 05/01/2018	Zach Jojola

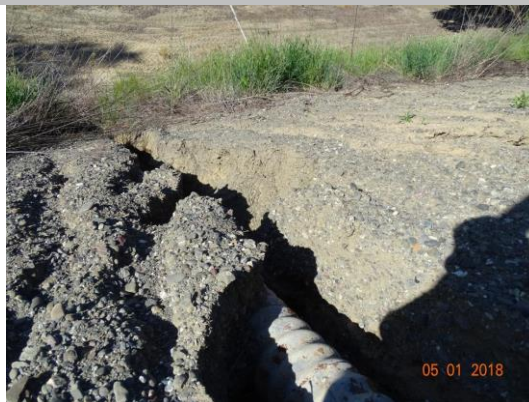
Photo 1 of 3 : SP_2018_RD0785_185_9_20180501_00053.jpg

LM Start	0.11	Rating **	U	Issue No.	9
LM End	0.11	Issue Type +	Ma	Location *	LS
Category	Earthen Levee			GPS Latitude/Longitude	
				Start	End
Item	Erosion / Bank Caving			38.660211 °	38.660211 °
				-121.611748 °	-121.611748 °
DWR ID	DWR_RD0785_01_f_2017_9				
Comment Code					
E2 : Schedule repair of erosion site prior to the next inspection.					
Inspector Comment					
Runoff erosion on landside slope that has gotten worse. The corrugated pipe is now exposed.

Updated view of runoff on the landside slope. Spring 2018.

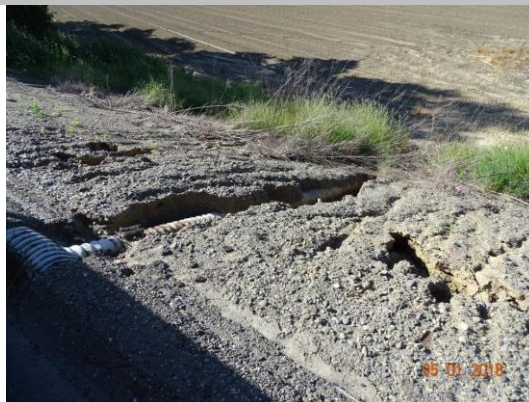
Photo 2 of 3 : SP_2018_RD0785_185_9_20180501_00052.jpg

Additional view of runoff on the landside slope. Spring 2018.

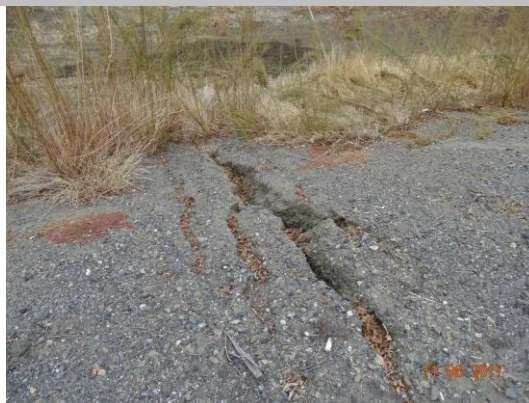
Photo 3 of 3 : SP_2018_RD0785_185_9_20180306_00006.jpg

LM Start	0.11	Rating **	U	Issue No.	9 (cont)	
LM End	0.11	Issue Type +	Ma	Location *	LS	
Category	Earthen Levee			GPS Latitude/Longitude		
				Start		End
Item	Erosion / Bank Caving			38.660211 °	38.660211 °	
				-121.611748 °	-121.611748 °	
DWR ID	DWR_RD0785_01_f_2017_9					
Comment Code						
E2 : Schedule repair of erosion site prior to the next inspection.						
Inspector Comment						
Runoff erosion on landside slope that has gotten worse. The corrugated pipe is now exposed.

View of runoff erosion on the landside slope. Fall 2017.

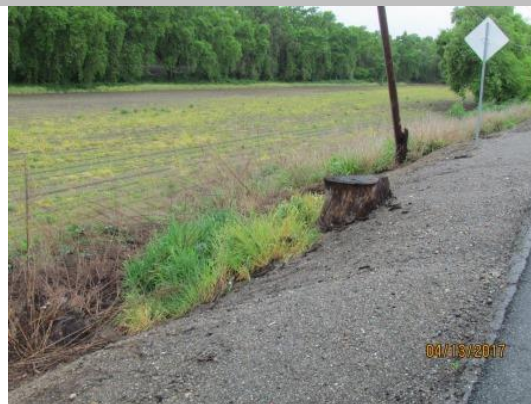
Photo 1 of 1 : SP_2018_RD0785_185_36_20180306_00025.jpg

LM Start	0.28	Rating **	N	Issue No.	36
LM End	0.28	Issue Type +	Ma	Location *	LS
Category	Earthen Levee			GPS Latitude/Longitude	
				Start	End
Item	Trim / Thin Trees			38.658537 °	38.658537 °
				-121.609675 °	-121.609675 °
DWR ID	DWR_RD0785_01_s_2017_36				
Comment Code					
T5 : Tree stumps.					
Inspector Comment

View of stump on landside levee slope. Spring 2017.

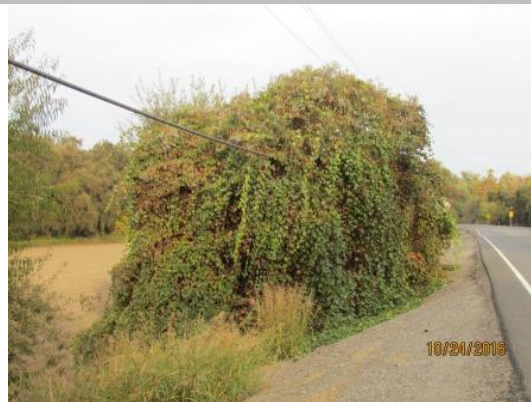
Photo 1 of 1 : SP_2018_RD0785_185_1_20180306_00001.jpg

LM Start	0.28	Rating **	A/W	Issue No.	1
LM End	0.28	Issue Type +	Ma	Location *	LS
Category	Earthen Levee			GPS Latitude/Longitude	
				Start	End
Item	Vegetation			38.658467 °	38.658467 °
				-121.609573 °	-121.609573 °
DWR ID	DWR_RD0785_01_s_2012_1				
Comment Code					
V4 : Elderberries are blocking visibility and flood fight capability.					
Inspector Comment

Elderberry tree on LS slope. Fall 2016.

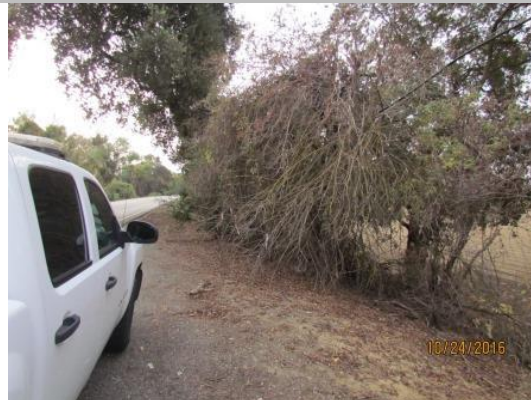
Photo 1 of 1 : SP_2018_RD0785_185_2_20180306_00002.jpg

LM Start	0.40	Rating **	A/W	Issue No.	2
LM End	0.44	Issue Type +	Ma	Location *	LS
Category	Earthen Levee			GPS Latitude/Longitude	
				Start	End
Item	Vegetation			38.657168 °	38.656697 °
				-121.608270 °	-121.607845 °
DWR ID	DWR_RD0785_01_s_2012_2				
Comment Code					
V4 : Elderberries are blocking visibility and flood fight capability.					
Inspector Comment

Elderberry tree on LS slope. Fall 2016.

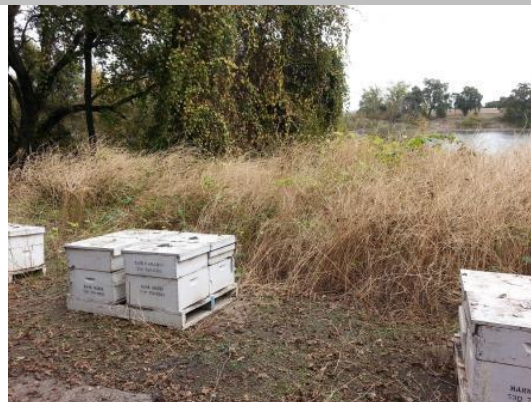
Photo 1 of 1 : SP_2018_RD0785_185_51_20180306_00035.jpg

LM Start	0.66	Rating **	M	Issue No.	51
LM End	0.66	Issue Type +	Ma	Location *	WS
Category	Earthen Levee			GPS Latitude/Longitude	
				Start	End
Item	Vegetation			38.654322 °	38.654322 °
				-121.605181 °	-121.605181 °
DWR ID	DWR_RD0785_01_f_2016_51				
Comment Code					
V2 : Remove the wild growth other than native grasses from the levee slopes.					
Inspector Comment

View of vegetation site on WS slope. Fall 2016.

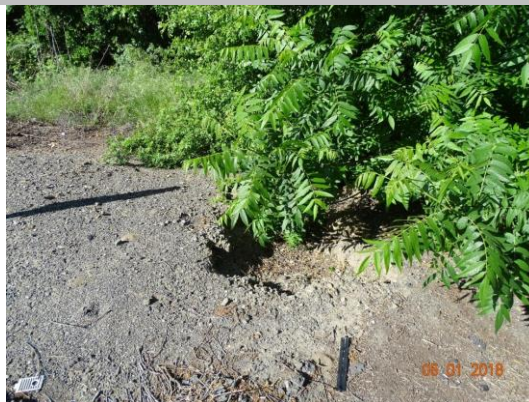
Photo 1 of 1 : SP_2018_RD0785_185_4_20180501_00054.jpg

LM Start	0.77	Rating **	A/W	Issue No.	4
LM End	0.77	Issue Type +	Ma	Location *	LS
Category	Earthen Levee			GPS Latitude/Longitude	
				Start	End
Item	Erosion / Bank Caving			38.652825 °	38.652825 °
				-121.604920 °	-121.604920 °
DWR ID	DWR_RD0785_01_s_2018_4				
Comment Code					
E1 : Note and monitor erosion site.					
Inspector Comment					
Minor runoff on landside slope. Recommend monitoring.

View of runoff erosion on the landside slope. Spring 2018.

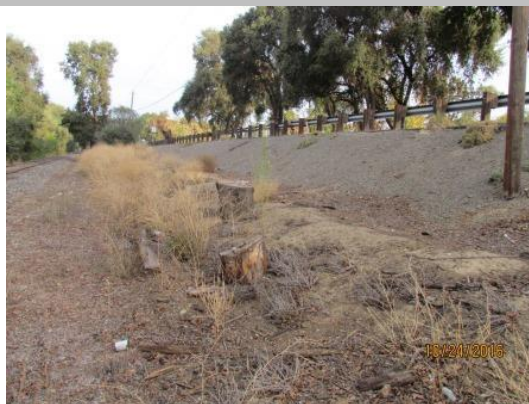
Photo 1 of 1 : SP_2018_RD0785_185_28_20180306_00018.jpg

LM Start	0.99	Rating **	N	Issue No.	28
LM End	0.99	Issue Type +	Ma	Location *	LS
Category	Earthen Levee			GPS Latitude/Longitude	
				Start	End
Item	Trim / Thin Trees			38.650055 °	38.650055 °
				-121.602752 °	-121.602752 °
DWR ID	DWR_RD0785_01_f_2016_28				
Comment Code					
T5 : Tree stumps.					
Inspector Comment

Two decomposing tree stumps near levee toe on landside. Fall 2016.

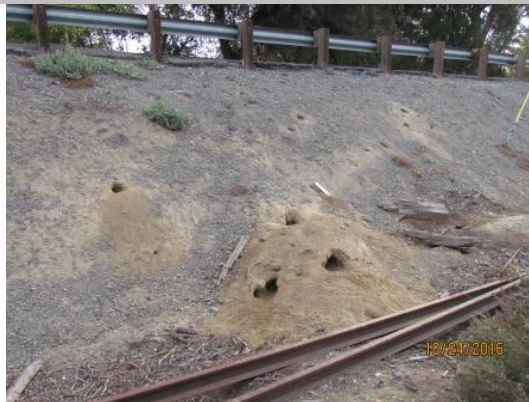
Photo 1 of 2 : SP_2018_RD0785_185_29_20180306_00019.jpg

LM Start	1.02	Rating **	M	Issue No.	29
LM End	1.02	Issue Type +	Ma	Location *	LS
Category	Earthen Levee			GPS Latitude/Longitude	
				Start	End
Item	Animal Control			38.649798 °	38.649798 °
				-121.602373 °	-121.602373 °
DWR ID	DWR_RD0785_01_f_2016_29				
Comment Code					
A3 : No rodents visible, but rodent burrows visible; need to backfill and compact or grout burrows.					
Inspector Comment					
Rodent holes on the landside slope.

View of rodent holes on LS slope. Fall 2016.

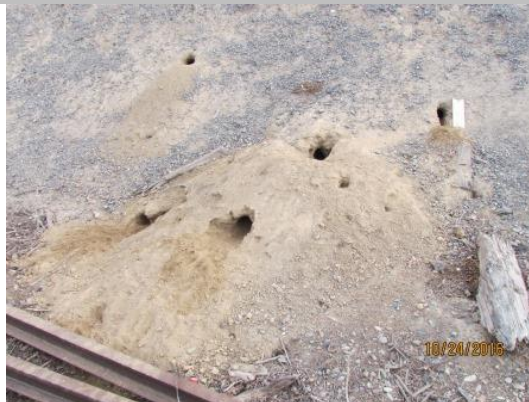
Photo 2 of 2 : SP_2018_RD0785_185_29_20180306_00020.jpg

Another view of rodent holes. Fall 2016.

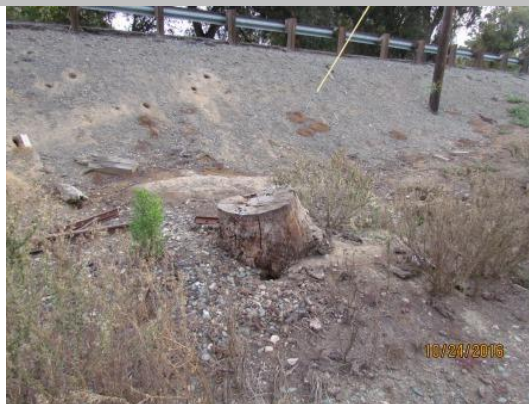
Photo 1 of 1 : SP_2018_RD0785_185_30_20180306_00021.jpg

LM Start	1.02	Rating **	N	Issue No.	30
LM End	1.02	Issue Type +	Ma	Location *	LS
Category	Earthen Levee			GPS Latitude/Longitude	
				Start	End
Item	Trim / Thin Trees			38.649775 °	38.649775 °
				-121.602363 °	-121.602363 °
DWR ID	DWR_RD0785_01_f_2016_30				
Comment Code					
T5 : Tree stumps.					
Inspector Comment					
Decomposing tree stump near levee toe

View of a decomposing stump near levee toe on landside. Fall 2016.

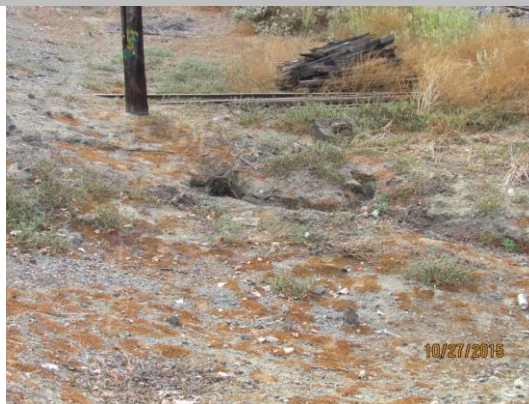
Photo 1 of 3 : SP_2018_RD0785_185_48_20180306_00031.jpg

LM Start	1.07	Rating **	M	Issue No.	48
LM End	1.07	Issue Type +	Ma	Location *	LS
Category	Earthen Levee			GPS Latitude/Longitude	
				Start	End
Item	Erosion / Bank Caving			38.649392 °	38.649392 °
				-121.601636 °	-121.601636 °
DWR ID	DWR_RD0785_01_s_2012_48				
Comment Code					
E2 : Schedule repair of erosion site prior to the next inspection.					
Inspector Comment

View of the erosion at the toe of the levee on the landward side of the levee looking downstream. Fall 2015.

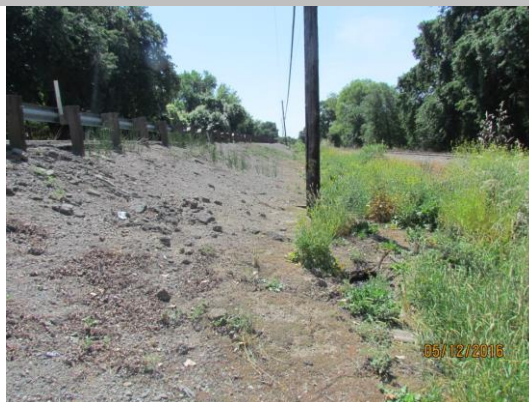
Photo 3 of 3 : SP_2018_RD0785_185_48_20180306_00033.jpg

Perspective view of the erosion on the landward side of the levee looking downstream. Spring 2016.

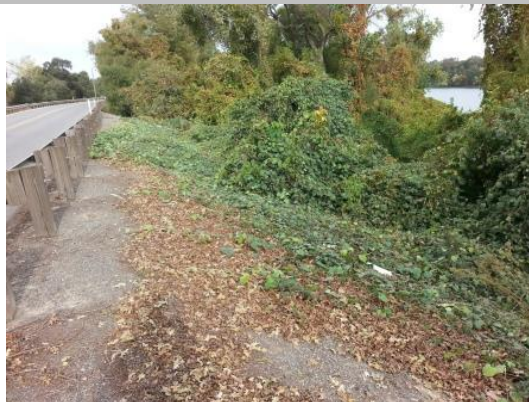
Photo 1 of 2 : SP_2018_RD0785_185_44_20180306_00028.jpg

Elderberry trees on WS slope Fall 2016.

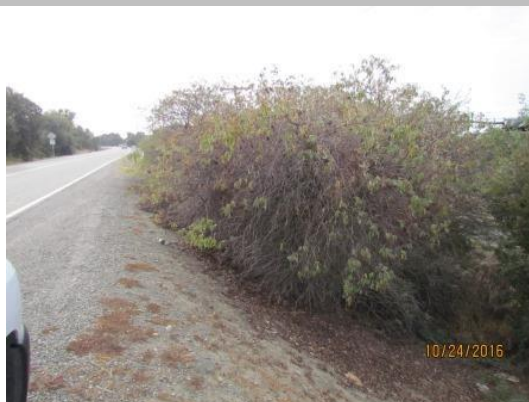
Photo 1 of 1 : SP_2018_RD0785_185_6_20180306_00004.jpg

LM Start	1.30	Rating **	A/W	Issue No.	6
LM End	1.30	Issue Type +	Ma	Location *	LS
Category	Earthen Levee			GPS Latitude/Longitude	
				Start	End
Item	Vegetation			38.646712 °	38.646712 °
				-121.599095 °	-121.599095 °
DWR ID	DWR_RD0785_01_s_2012_6				
Comment Code					
V4 : Elderberries are blocking visibility and flood fight capability.					
Inspector Comment

View of elderberry trees on LS slope. Fall 2016.

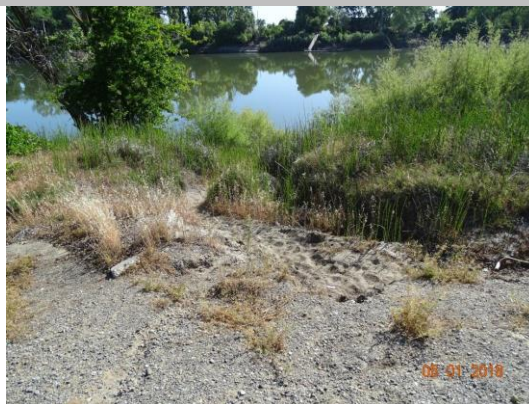
Photo 1 of 4 : SP_2018_RD0785_185_13_20180501_00051.jpg

LM Start	1.31	Rating **	M	Issue No.	13
LM End	1.31	Issue Type +	Ma	Location *	WS
Category	Earthen Levee			GPS Latitude/Longitude	
				Start	End
Item	Slope Stability			38.646652 °	38.646652 °
				-121.598907 °	-121.598907 °
DWR ID	DWR_RD0785_01_s_2013_13				
Comment Code					
S2 : Repair the levee slope damaged by foot traffic and prevent access where possible.					
Inspector Comment					
Footpath still visible on the waterside slope.

Updated view of slope stability on the waterside slope. Spring 2018.

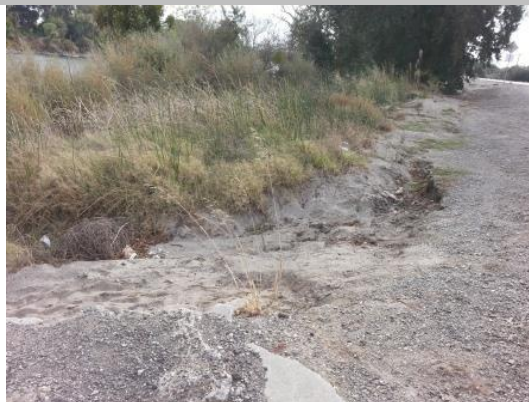
Photo 2 of 4 : SP_2018_RD0785_185_13_20180306_00007.jpg

Updated view of the slope stability site. Fall 2016.

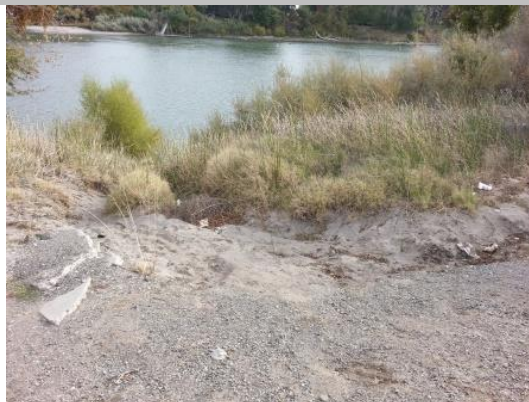
Photo 3 of 4 : SP_2018_RD0785_185_13_20180306_00008.jpg

Updated view of the slope stability site. Fall 2016.

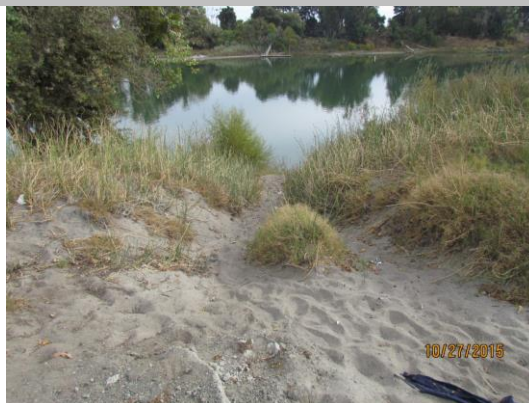
Photo 4 of 4 : SP_2018_RD0785_185_13_20180306_00009.jpg

LM Start	1.31	Rating **	M	Issue No.	13 (cont)	
LM End	1.31	Issue Type +	Ma	Location *	WS	
Category	Earthen Levee			GPS Latitude/Longitude		
				Start		End
Item	Slope Stability			38.646652 °		38.646652 °
				-121.598907 °		-121.598907 °
DWR ID	DWR_RD0785_01_s_2013_13					
Comment Code						
S2 : Repair the levee slope damaged by foot traffic and prevent access where possible.						
Inspector Comment						
Footpath still visible on the waterside slope.

View of the slope stability on the waterward side of the levee. Fall 2015.

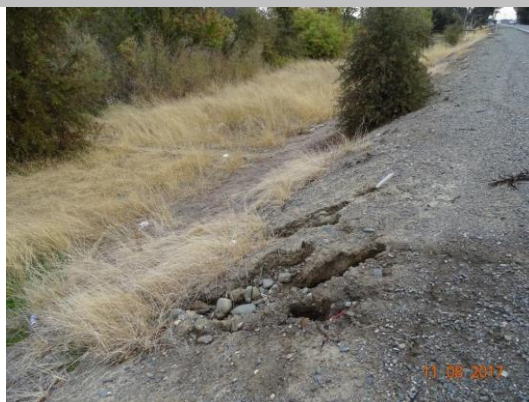
Photo 1 of 1 : SP_2018_RD0785_185_55_20180306_00036.jpg

LM Start	1.51	Rating **	M	Issue No.	55	
LM End	1.51	Issue Type +	Ma	Location *	WS	
Category	Earthen Levee			GPS Latitude/Longitude		
				Start		End
Item	Erosion / Bank Caving			38.644349 °		38.644349 °
				-121.596506 °		-121.596506 °
DWR ID	DWR_RD0785_01_f_2017_55					
Comment Code						
E2 : Schedule repair of erosion site prior to the next inspection.						
Inspector Comment						
Runoff on waterside slope.

View of the runoff erosion on the waterside slope. Fall 2017.

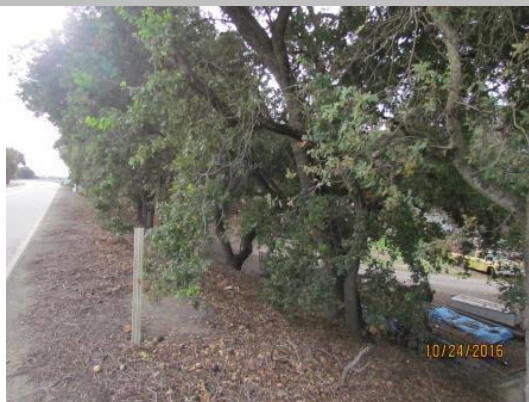
Photo 1 of 1 : SP_2018_RD0785_185_22_20180306_00016.jpg

LM Start	1.61	Rating **	M	Issue No.	22
LM End	1.62	Issue Type +	Ma	Location *	LS
Category	Earthen Levee			GPS Latitude/Longitude	
				Start	End
Item	Trim / Thin Trees			38.643359 °	38.643229 °
				-121.595237 °	-121.595011 °
DWR ID	DWR_RD0785_01_s_2016_22				
Comment Code					
T1 : Trim trees to at least five feet above ground level.					
Inspector Comment					
Trees still need trimming.

Fall 2016.

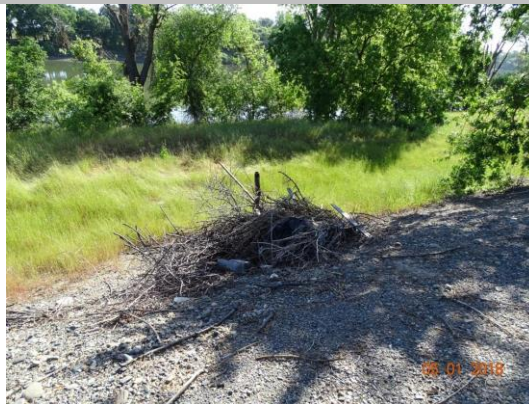
Photo 1 of 1 : SP_2018_RD0785_185_25_20180501_00050.jpg

View of pruning pile on the waterside slope. Spring 2018.

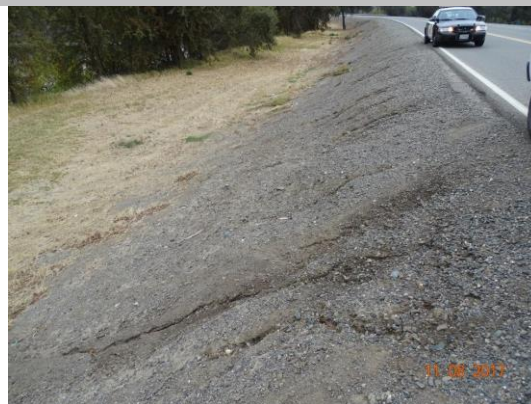
Photo 1 of 1 : SP_2018_RD0785_185_19_20180306_00014.jpg

LM Start	2.23	Rating **	A/W	Issue No.	19
LM End	2.23	Issue Type +	Ma	Location *	WS
Category	Earthen Levee		GPS Latitude/Longitude		
			Start	End	
Item	Erosion / Bank Caving		38.642908 °	38.642908 °	
			-121.584647 °	-121.584647 °	
DWR ID	DWR_RD0785_01_s_2018_19				
Comment Code					
E1 : Note and monitor erosion site.					
Inspector Comment					
Runoff erosion on waterside slope. Recommend monitoring.

View of runoff erosion on the waterside slope. Fall 2017.

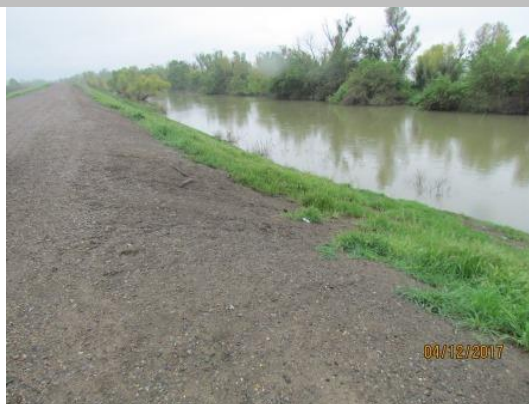
Photo 1 of 1 : SP_2018_RD0785_186_24_20180306_00006.jpg

LM Start	1.52	Rating **	M	Issue No.	24
LM End	1.52	Issue Type +	Ma	Location *	WS
Category	Earthen Levee			GPS Latitude/Longitude	
				Start	End
Item	Slope Stability			38.621694 °	38.621694 °
				-121.607610 °	-121.607610 °
DWR ID	DWR_RD0785_02_s_2017_24				
Comment Code					
S2 : Repair the levee slope damaged by foot traffic and prevent access where possible.					
Inspector Comment					
Footpath for environmental access site. There is a noticeable dip on the waterside slope.

View of slope stability on waterside levee slope. Spring 2017.

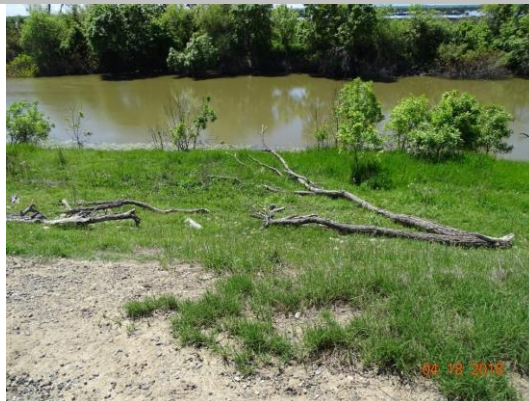
Photo 1 of 1 : SP_2018_RD0785_186_4_20180419_00010.jpg

View of tree branches on the waterside slope. Spring 2018.
